# Inventory Mapping and Characterization of Landslides Using LiDAR

Inventory Mapping and Characterization of Landslides Using LiDAR: Kenton and Campbell Counties, Kentucky

Matt Crawford

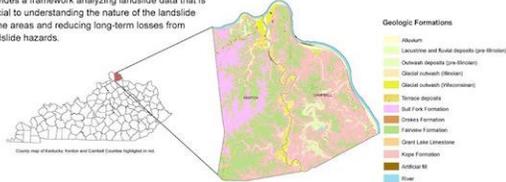
KY 177: Slide above and below road, note old retaining wall.

Licking Pike: Scarp and cracks in pavement, slide above and below road

KY 8: Leaning telephone poles on large slide above and below road

KY 1072: Old embankment failure

Many of the confirmed landslides could be seen from the road, and road damage typically was associated with them (fig. 5). Recent scarps also were present in many slides, and deposition was active toward the toe of the slide. Determining the location of potential landslides was a subjective process. For example, a potential landslide might have been identified on a slope, and slumping in the road below it provided field verification, but it was not clear whether there was active sliding above the road or if there was geologic control on the geomorphology of the slope. Many of these slopes are creeping, but distinguishing between active creep and relict, non-active movement makes attribution difficult.

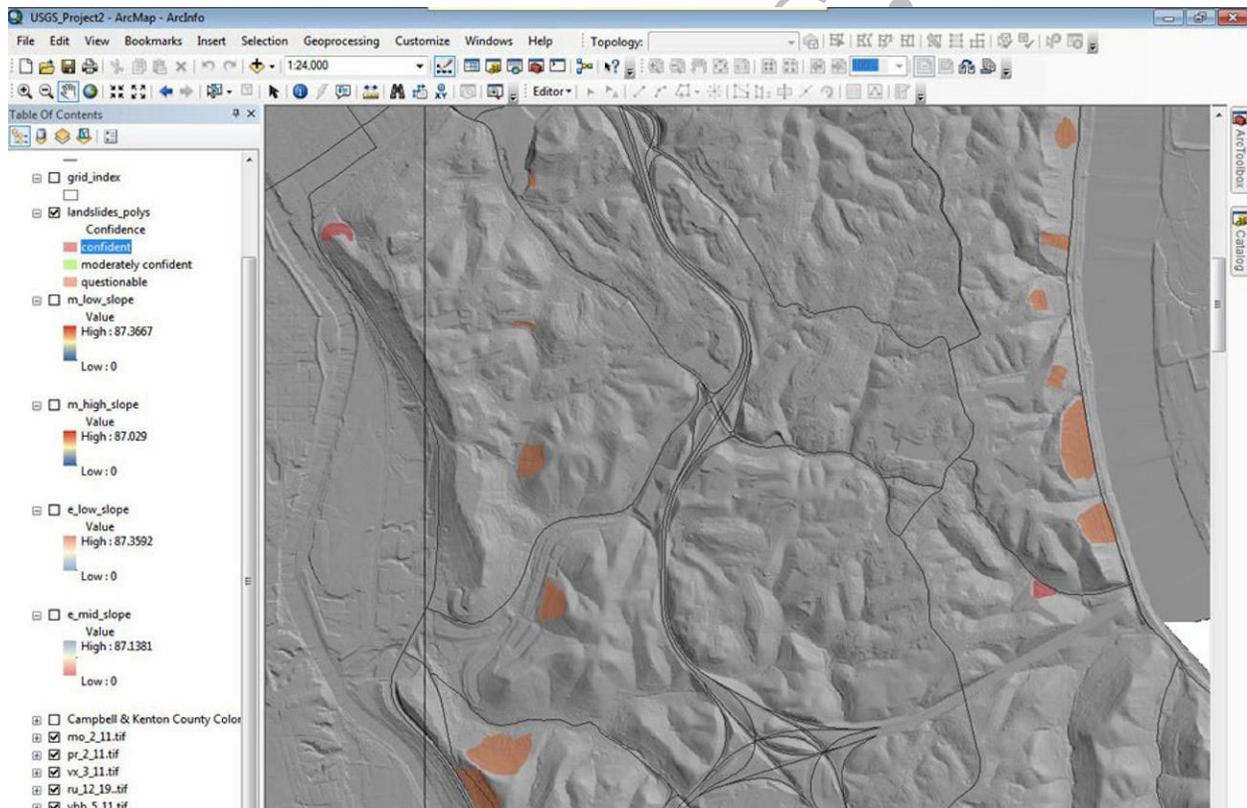
**Fig 3: ArcMap project showing a bare-earth LiDAR hillshade DEM and mapped landslides.**

Potential preexisting, previously undetected landslides were identified by visual examination of slope morphology at different scales. The bare-earth hillshade DEMs were used in ArcMap to map potential landslides (fig. 3). ArcMap allows for other data sets (contours, aerial photography, geology, and others) to be used in conjunction with the LiDAR. The hillshade DEMs were systematically panned at various scales to identify and digitize the areal extent of potential landslides. Draping the topographic contours over the hillshade was important for accentuating the slope geomorphology. A reference grid was used to help organize the panning and zooming across the DEMs. Examination was done at 1:10,000, 1:5,000, and 1:2,000 scales. All digitizing of potential landslide extents was done at a scale of 1:2,000. Potential landslides were primarily identified and mapped on the basis of geomorphic expression on the hillshade models. Steep scarps, hummocky terrain, concave and convex areas, and thick toeslopes were possible indicators of landslides. Changes in contour spacing helped accentuate thick toeslopes where the landslide deposits had spread out, creating a gentler slope. The geology and leaf-off aerial photography also were used in the visualization and analysis processes. Evidence of landslides, such as repaired roads and leaning trees, occasionally was seen in the aerial imagery.

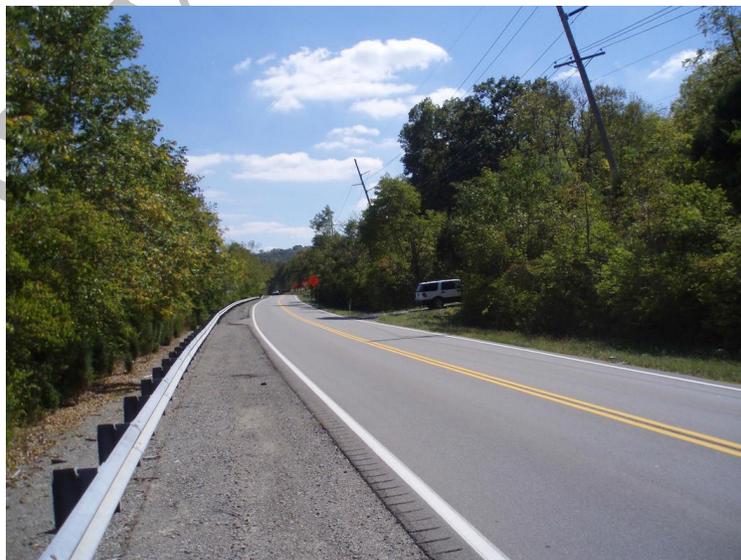
**Fig 4: Photograph of landslide area along KY 8. Note leaning telephone pole.**

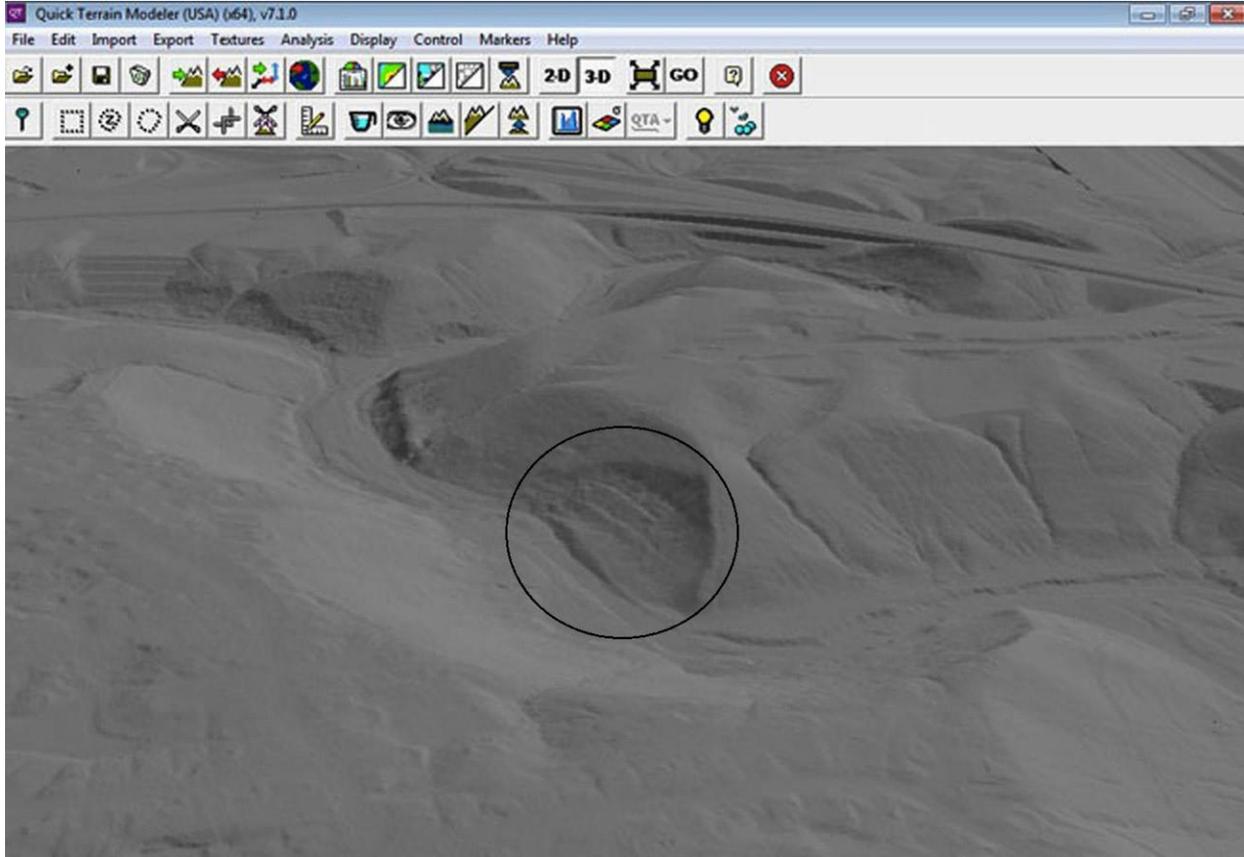
**Fig 5: Rotated 3D view of LiDAR hillshade in Quick Terrain Modeler that accentuates the geomorphology when azimuth and sun angle are changed. Landslide is circled.**

After initial identification of potential landslides in ArcMap, selected digitized features were reexamined in Quick Terrain Modeler for verification. This software allows for the rapid change of azimuths and sun angles (fig. 4). Different lighting and perspective on slope geomorphology and potential landslides help with assigning the confidence level. Scarps or concavity observed with one sun angle may appear completely different with other lighting orientations. In addition, Quick Terrain Modeler allows for 3D visualization, whereas ArcMap is best for 2D map view of data sets. Using rapid zooming and panning tools with 3D was very helpful in assigning confidence to the digitized landslide extents, confirming well-defined scarps, flanks, or thick toeslopes. Approximately 25 percent of the slides (about 50) identified using ArcMap were viewed in 3D with various lighting orientations. For about half of those, the confidence was changed from questionable to moderately confident, and the other half remained as questionable. Potential landslides that initially were attributed as questionable and not viewed in 3D were left as questionable.

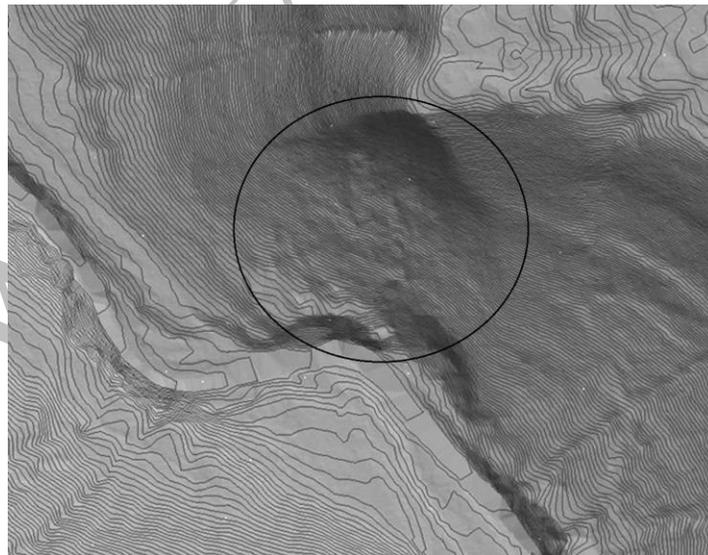
**Fig 6: Mapped landslide on LiDAR hillshade draped with topographic contours (2 ft). Slide occurs at cutbank in a stream at the toe and is approximately 455 ft long down the axis of the slide. Note hummocky surface of slide area, slide flanks, and steep scarp area near the top of the slope.**

Two hundred thirty-four potential landslides were detected in Kenton and Campbell Counties, and their extents were digitized. Twenty landslides (approximately 9 percent) were initially attributed as confident (fig. 6). The other slides were attributed as questionable or moderately confident (fig. 7). The LiDAR hillshade geomorphology, geology, and proximity to urbanized areas dictated the initial classification. Reexamination in Quick Terrain Modeler changed the initial classification (that is, from questionable to confident, or vice versa) of some of the slides. Landslides were not deleted from or added to the inventory after Quick Terrain Modeler was used. Forty-five landslides (approximately 20 percent) were field-checked. Of those, 20 were confirmed, 18 were likely or observed but could not be determined, and 7 were not accessible. Landslide type (translational or rotational) was not determined by LiDAR visualization. If landslide type could be determined in the field, then it was noted. Many of the landslides mapped are not associated with roadways and are in rural, wooded areas that are on private property. Using airborne LiDAR for detailed inventory mapping significantly improves awareness of landslide locations not previously known, especially in forested and suburban landscapes.

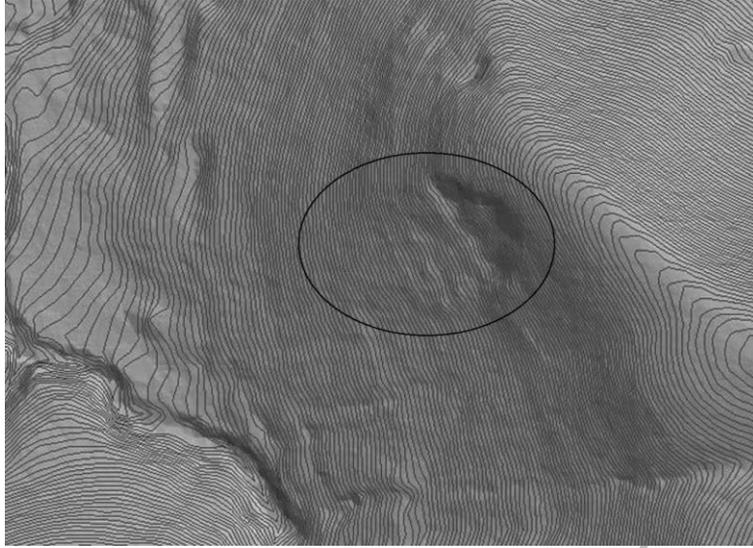
**Fig 7: Mapped landslide on LiDAR hillshade draped with topographic contours (2 ft). Slide occurs mid-slope and is approximately 280 ft long down the axis of the slide. Note hummocky surface of slide area and steep scarp. This slide occurs in a wooded area that otherwise would not have been recognized.**
